ACOUSTIC EMISSION MONITORING OF CRACK PROPAGATION ON THE EXPEDITED WING FATIGUE TEST ARTICLE (X993)

LOCKHEED-GEORGIA COMPANY
DIVISION OF LOCKHEED AIRCRAFT CORPORATION
MARIETTA, GEORGIA 30063

DECEMBER 1976

FINAL REPORT JUNE 1975 - OCTOBER 1976

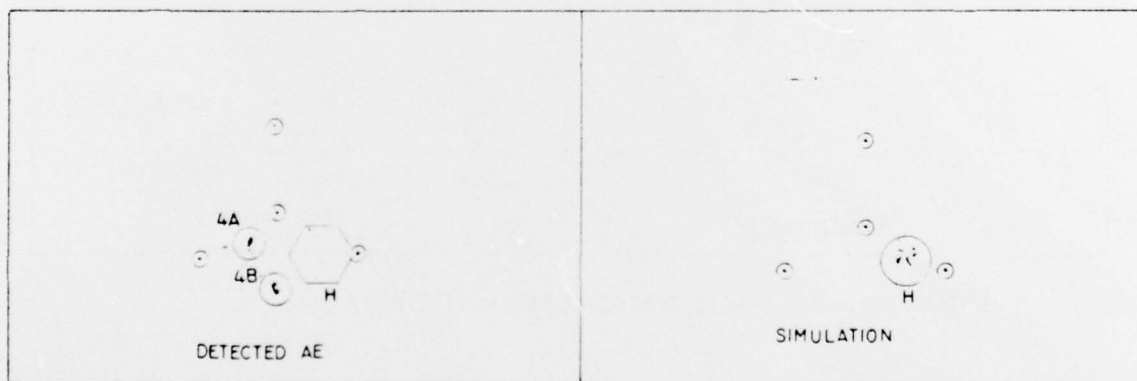
FIGURE H6. AE REPRESENTATIONS FROM TEST AREA 4

Triangular presentation on left shows repetitive AE detected
during flights from test hole H and suspect areas 4A and 4B,
all in test area 4. The presentation on right shows simulations
made at test hole H, with bolt removed.

Test Area 4, Test Hole H. This was another noisy area and the early linear array could not reliably show crack growth AE. The 8-inch triangular array installed next allowed scattering of the indications from noise and AE sources, hindering reliable assessment. A larger triangular array was installed and it included the center wing

panel 2-to-panel 3 splice. It successfully displayed AE from test hole H and two other emitters designated 4A and 4B. A plot of AE from test hole H is shown in Figure 11 and the data are tabulated in Table I. A distinct decrease in the AE rate was experienced after modifying the array, but this was eventually corrected by optimizing the channel gains. (Data from 4A and 4B are also tabulated in Appendix E.)

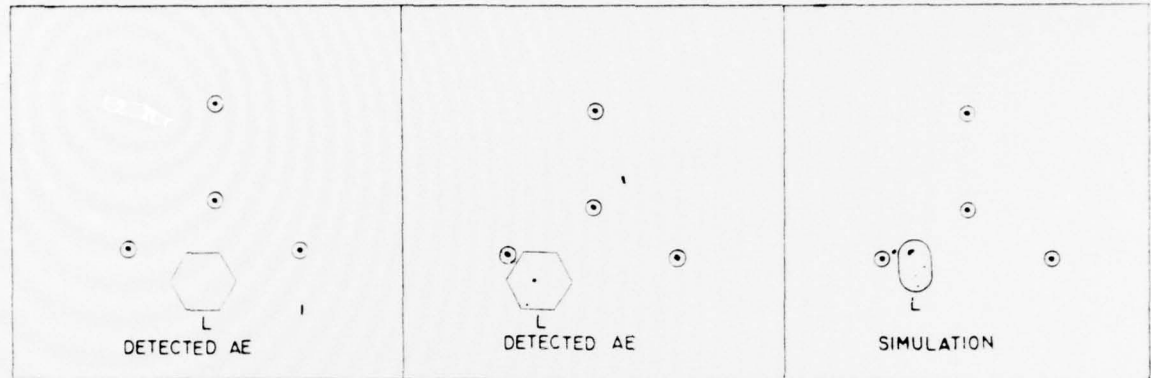
FIGURE H7. AE REPRESENTATIONS FROM TEST AREA 6

Triangular presentation on left shows AE detected during flight loading from test hole L using the "rotated" array. Center presentation is AE from test hole L before the array was rotated (after flight 436). Right presentation are simulations made of test hole L with bolt removed before the array was rotated.

Test Area 6, Test Hole L. The triangular array installed in this area following the 100 precrack flights was improved by "rotating" the array after 435 flights. AE from the small amount of crack growth experienced in hole L was persistent, but not constant. The AE is plotted in Figure 11 and the data are tabulated in Table I. Another unidentified emitter or noise source existed within the chordwise splice in this area.

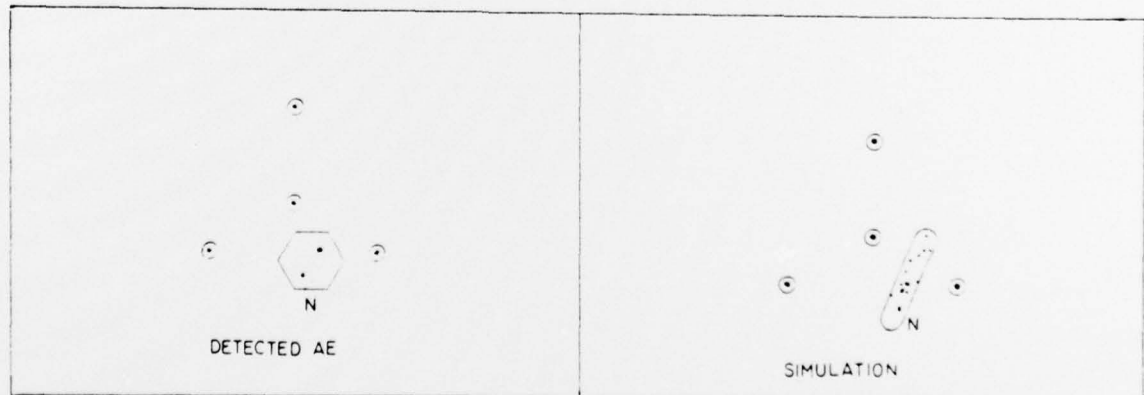
FIGURE H8. AE REPRESENTATIONS FROM TEST AREA 8

Triangular presentation on left is AE detected during flights 790 to 796 at test hole N. Right presentation shows simulations made at test hole N.

Test Area 8, Test Hole N. AE indications were received from Test Hole N throughout the first 1200 flights, after which the material containing the crack was removed for fractographic examinations. An improvement in detection was obtained when the array was "rotated" prior to flight 438.

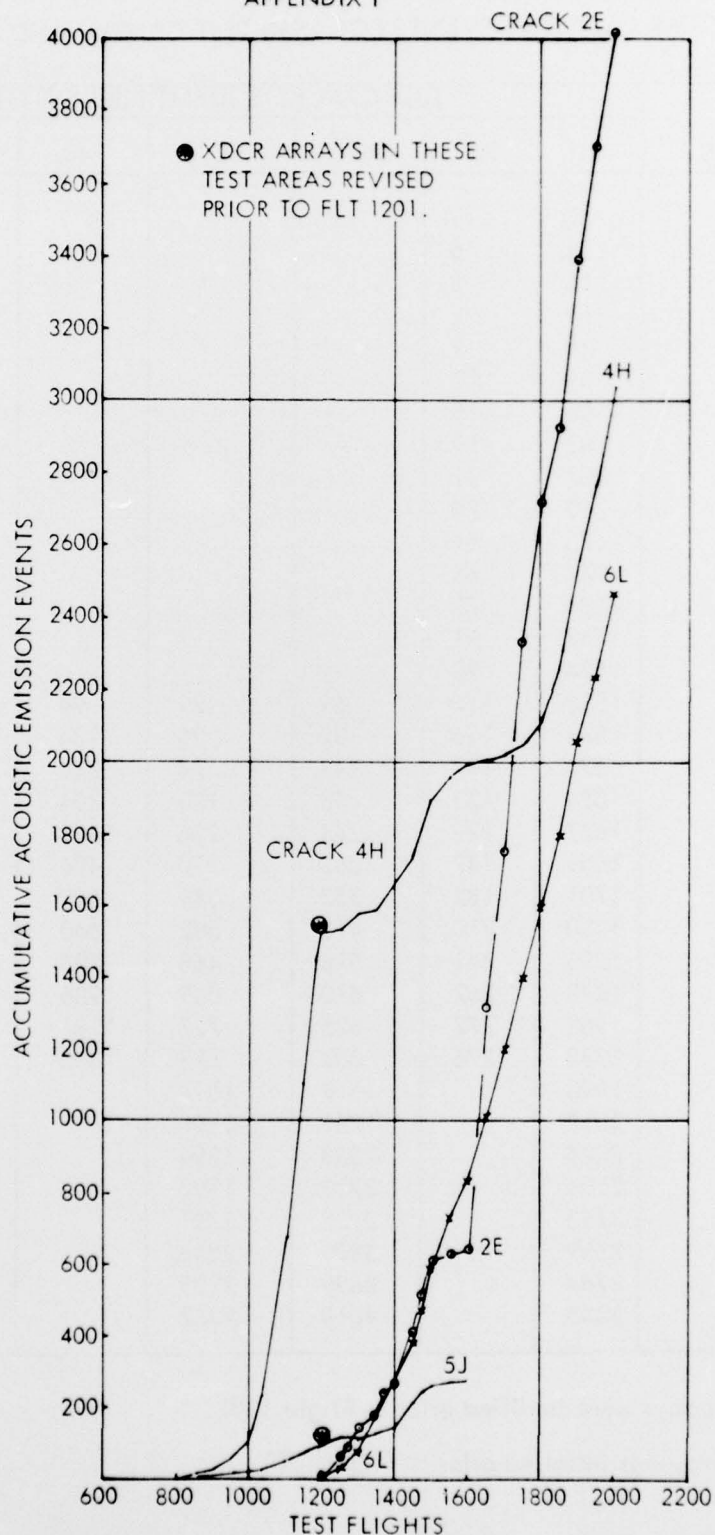
FIGURE 11. ACCUMULATIVE AE EVENTS VERSUS TEST FLIGHTS FOR FOUR TEST CRACKS

Test Area 2, Test Holes D and E. Early attempts to monitor growth at these test holes were not successful using a linear array. After a triangular array was mounted on the beam cap following flight 1200, this array consistently picked up AE from hole E through flight 2000. These are plotted in Figure 11 and tabulated in Table I. The occasional emissions from hole D lost intensity in propagating from the web to the array and were, therefore, less reliably indicated.

Test Area 5, Test Holes I, J and K. AE from hole J was received by the initial triangular array until the crack reached the lower edge of the web just prior to flight 1600. The crack was removed at the end of 1650 flights for fractographic examination. A plot of the AE from J is shown in Figure 11 and the data are tabulated in Table i. The emission rate was very sporadic throughout the flights. AE from holes I and K were not identifiable as coming from a distinct source. This was attributed to the complex stiffener and cap splice joints and to the positioning of the array so that I and K were in the vicinity of the apex transducers 1 and 2, respectively (see Section 3.1.4B). The final experimental array installed following Flight 1600 did not reliably indicate emissions from holes I and K. Several early extraneous emitters were located at fastener holes in a nearby stiffener attachment area and were found to be related to loose fasteners.
